BAUXITE MINING IN WESTERN GUINEA

IDI in support of communities in the Sangaredi region V: Rehabilitated land

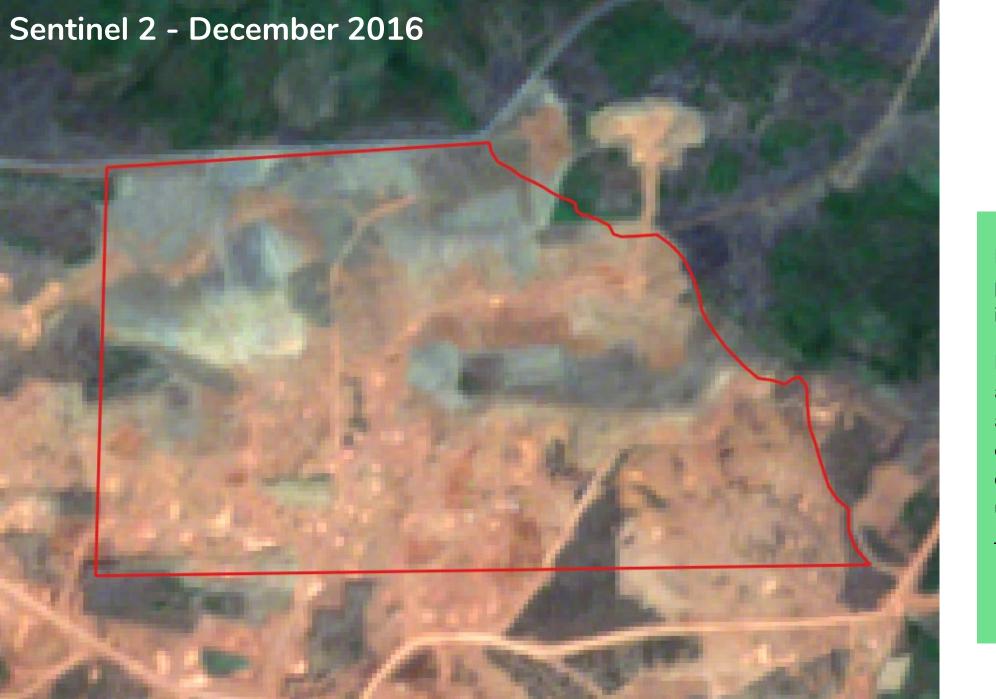
New Hamdallaye perimeter marked in red.

Mining reportedly ended in May 2016.

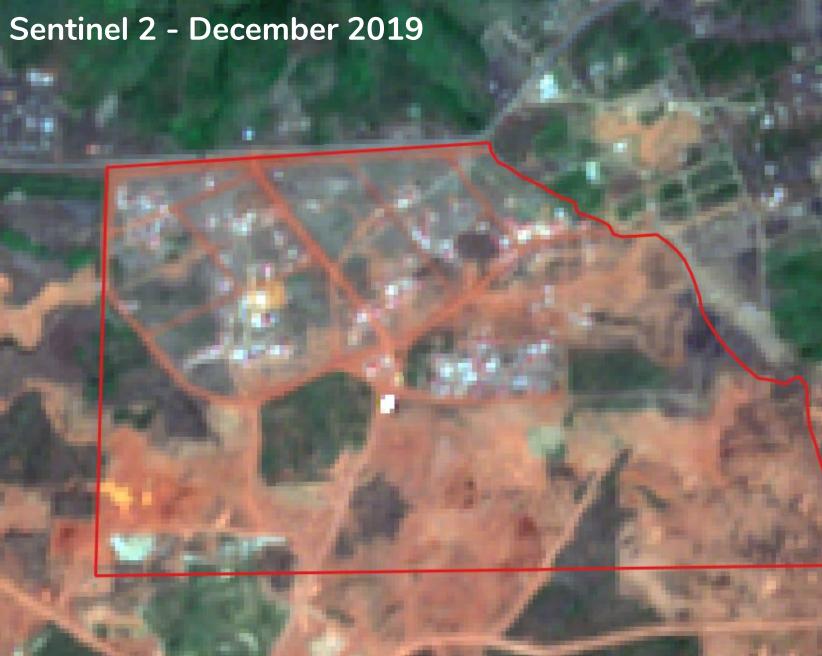
Sentinel 2 - December 2018

New Hamdallaye perimeter marked in red.

Construction underway in the northern area set aside for housing. No rehabilitation visible in southern area set aside for agriculture.
