RICHARD L. MEEHAN

**April 17, 2020**

**Re: Dairi Prima Minerals (DPM) Mine site risks and Tailings disposal safety.**

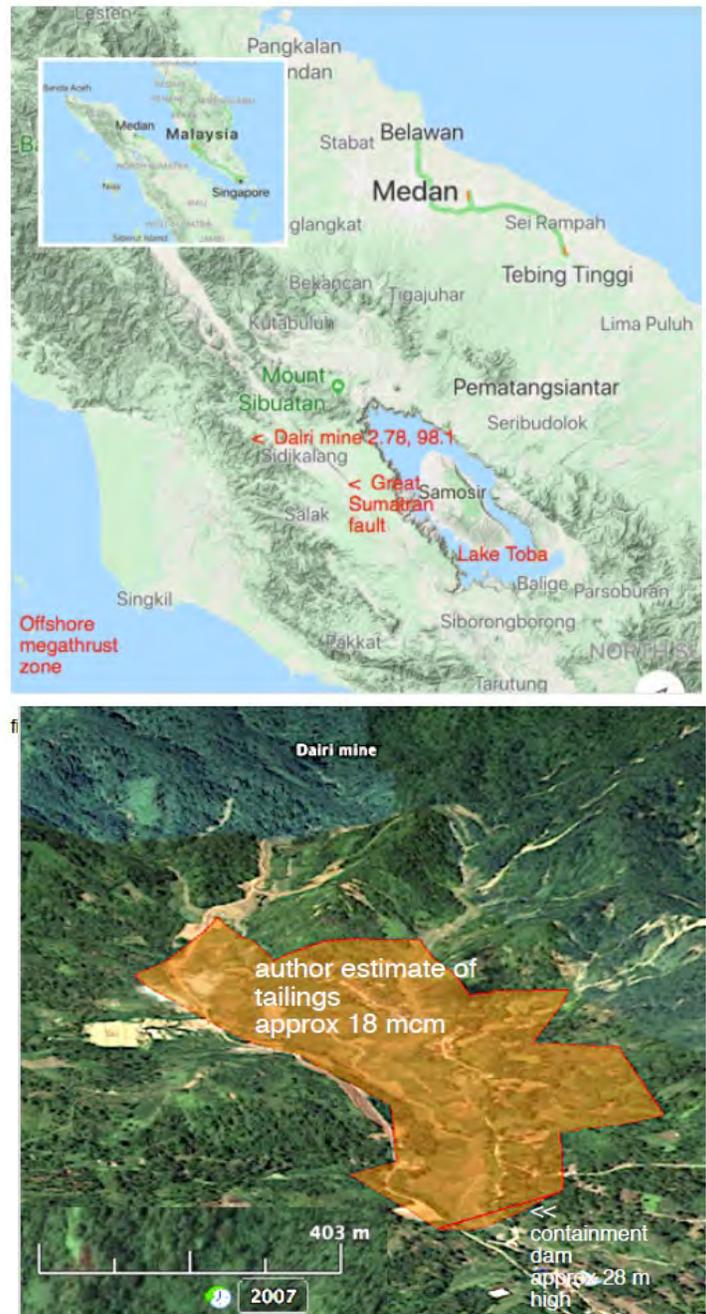
Figure 2. View of author's estimate of tailings

For the current 30 mt plan, I estimate the volume of above-ground storage for the waste slurry would be on the order of 10 mcm. Additional volume would be required to hold stormwater and landslide debris (see below) and whatever freeboard (reserve storage) is required for safety. Altogether my working estimate for full capacity of the storage facility is about 18 mcm. If this is correct, that would require a tailings facility as shown in figure 2. Note that this estimate assumes complete success in the paste backfill plan, which as yet has not been demonstrated in terms of economics (millions of tons of expensive cement will be needed), technical aspects (a successful recipe has not been shown) or safety (the paste backfill could increase the possibility of toxic chemical leakage from the abandoned mine into the environment).

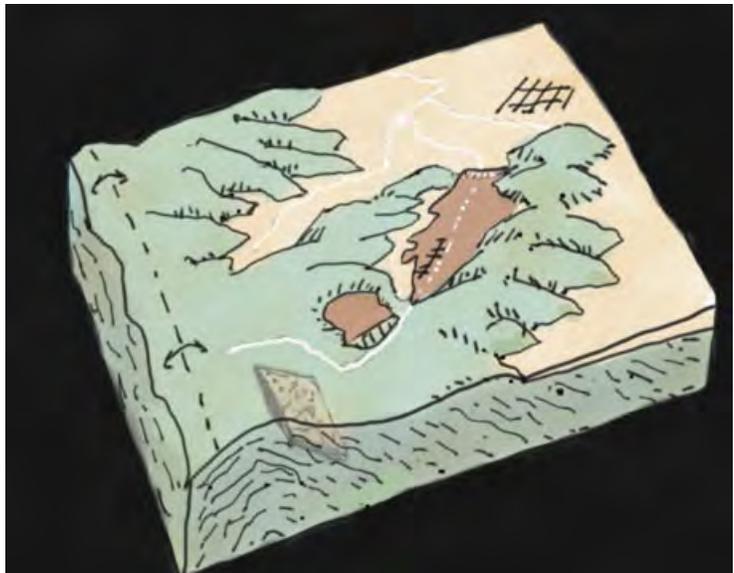
*Figure 3a Sketch of general geological features and reported alternate tailings dam disposal areas.*

Of special importance are the characteristics of foundation in tailings dam areas. Rocks underlying the entire project area (and containing the various ore bodies) are dominantly very old (Permo-Carboniferous) rocks, carbonaceous shale and dolomitic siltstones, which have been faulted and folding by plate convergence in the Sumatran west coast (Pale green in Figure 3a). According to Middleton 2003 the formation consists of tilted beds with an EW strike and a northerly dip of about 45 degrees with fracturing from brittle tectonic deformation. Inspection of various photos showing recent (2019) road cuts in the Sopokomil valley suggest that the sequence of dipping beds carries down northerly into the hills that flank the valley as shown in my sketch fig 3a.

The eruption of the Toba caldera some 70k years ago flooded the region with hot ash flows (ignimbrite), generally described as the Toba Tuff (pale yellow in Figure 3a). According to Middleton (apparently based on Aldiss et al, 1983) these deposits underlie the Sopokomil valley floor, site of the proposed tailings area. These volcanic deposits are generally taken to be variably cemented ("welded") but reportedly near the surface often take the form of a light ashy deposit which are found in some stream bank deposits according to photographs which I have seen. Aldiss et al describe the shallower tuffs regionally as being air-fall, unwelded, and often fluvially

reworked. This type of rock is usually low in density, subject to disintegrative weathering, and even where welded, fractured and water-bearing. The interface between the tuff and underlying older rock, at depth unknown here, is often highly permeable and a potential zone of instability because of its water-carrying capacity. An example of such instability is presented in a paper (Gratchev et al, 2011) on the 2007 earthquake at some distance from Dairi but in similar terrain where large landslides of tuff deposits burying villages with many casualties were triggered in 2007 by a combination of earthquake and heavy rainfall.

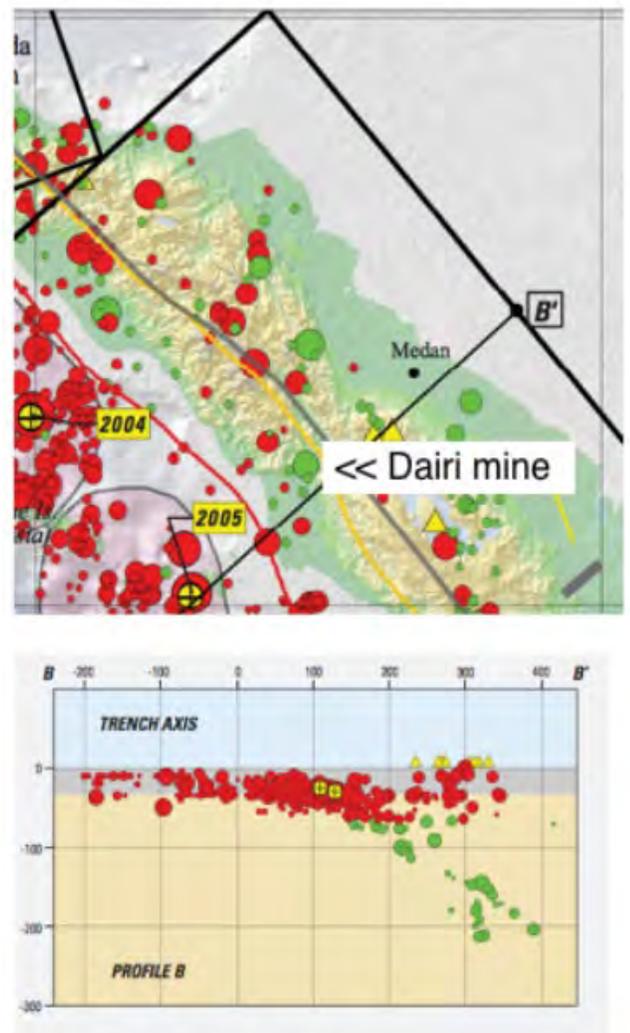
Figure 3. Historical earthquake per

The mine is located in one of the world's most active earthquake regions, along the Sumatra subduction megathrust apparently near a triple plate junction which produced in 2004 and 2005 earthquakes of magnitude 9 and 8+ respectively (fig 3). These events rocked buildings as far away as Bangkok and produced intense regional damage including to road embankments and bridge abutments, which are similar in their behavior to tailings dams. Intensity of ground motion produced destruction of facilities at Banda Aceh, which is a comparable distance from the earthquake to the Dairi mine. Japanese investigators (see Sorenson et al) found that damage was up to about level 6, Japanese JMA scale. This damage category (6.0-6.4) produces these effects:

A map and cross section showing historical earthquakes is extracted from a comprehensive summary of seismicity of the area published by the US Geological Survey (USGS, 2003). This map and many other publications provide comprehensive information on regional seismicity sufficient to evaluate earthquake risk.

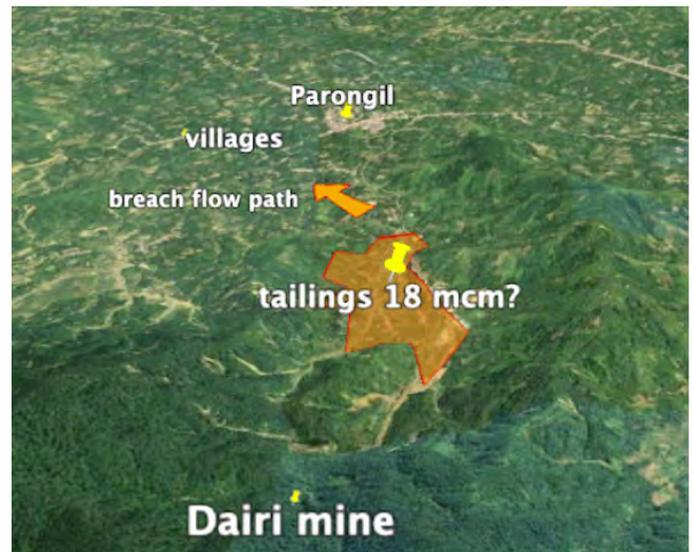
Figure 4. Path of mud wave if a breach occurs.

In summary, the proposed Dairi Mine is located in one of the highest earthquake risk areas in the world. While it is unclear how DPM intend to deal with the possible volume of tailings, I cannot avoid the conclusion that within a few decades after the "closure" of the deposit there will likely be an earthquake-induced sudden failure of a tailings dam, with a disastrous breach sending a wave of liquid mud downstream to the north.

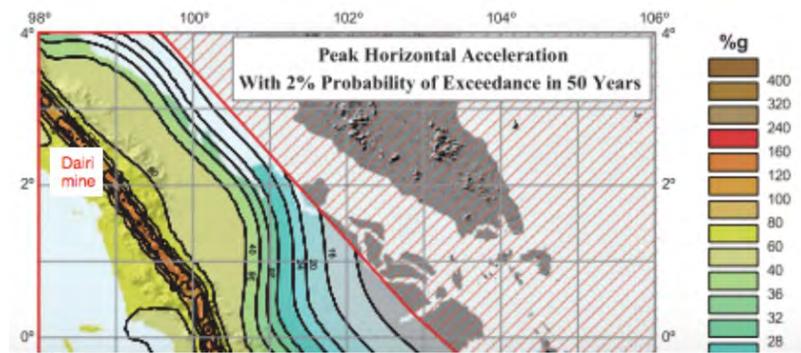
Although the offshore subduction zone mega earthquake poses a threat to long-period structures like tailings deposits, a more dangerous type of earthquake can be expected from the Great Sumatra fault which breaks ground only 15 km to the east of the Dairi site. According to Peterson et al (Ref Peterson) and others this fault is capable of generating earthquakes up to magnitude 7.5 to 7.9 and at this close distance are likely to produce very high ground accelerations on the order of 50-100% gravity (Figure 5).

figure 5. Tailings dam very close to Sumatra fault with likely earthquakes up to M 7.5-7.9 and ground accelerations of 100%g

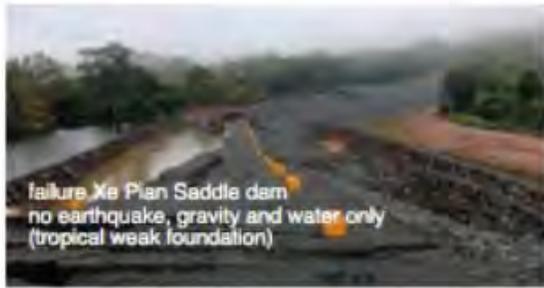
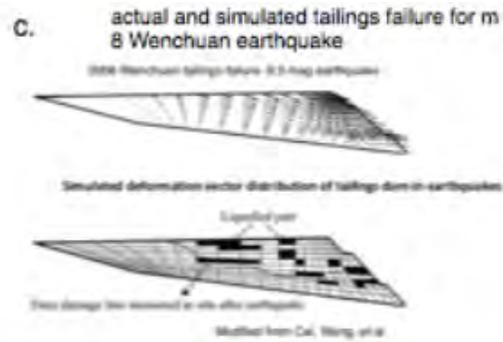
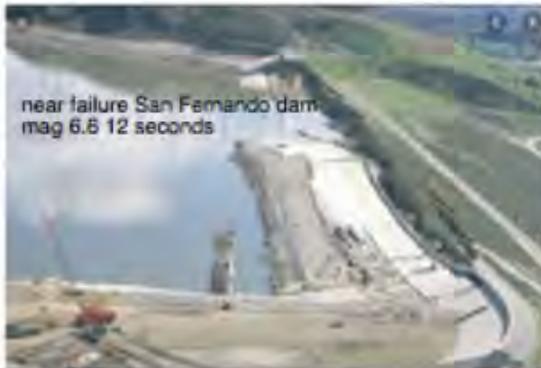
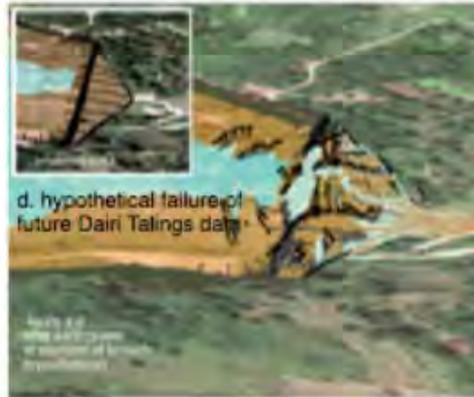
Failure of the containment for wet tailings would be most dangerous in the wet season with an abundance of water added to the containment. Cracking and sliding of the retaining structure would initially take on the appearance of the partial failure of the San Fernando dam, figure 6b (Castro et al 2003). But the San Fernando dam was subjected to only a few seconds of strong shaking. Larger earthquake from m 7.5 to 9 would produce shaking that would be much longer in duration with cracks and sliding of many meters in even robustly built dams. This would open the embankment to through flow of water and wet tailings, which would breach the Dairi containment (as in the Baldwin Hills Reservoir shown on video at <https://www.youtube.com/watch?v=c4sm7DdIMkk>) and also the Brazilian Brumadinho Mine.

figure 6. a. Failure of Xe Pian dam in Laos 2008; dam breached shortly after this photo with runoff of 500 mcm water flowing 100 km and obliterating 6 villages. No earthquake here, but poorly built dam founded on typical weak leaky tropical soils made dam unable to survive filling of the reservoir b. Near failure of the San Fernando dam in California in a short m 6.6 earthquake. Another few seconds of shaking would have breached this dam with a great death toll. c Analysis by Cai, Wang, et al of a tailings dam in the 2008 Wenchuan earthquake shows that the dam fails in a m=8 earthquake. d. Likely performance of a tailings dam at Dai Ri mine during a very strong earthquakes, probably from the Great Sumatran fault zone near the site.
